## MEETING MINUTES PUBLIC WORKS COUNCIL COMMITTEE West Des Moines City Hall Training Room May 13, 2015

Project: Law Enforcement Center Roof Replacement

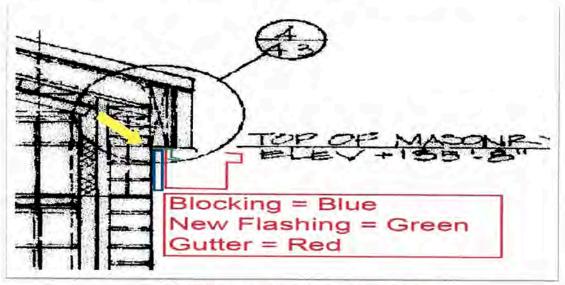
Detail 1: Box gutter installation detail (not to scale).

A large amount of staining is reoccurring along the North elevation. SystemWorks and ESM reviewed the new box style gutter along this elevation. This is not a seamless system. The gutter is manufactured in 10 foot lengths and assembled in the field using rivets, Figure 16. It appears ice buildup has damaged multiple joints. The damaged joint shown in Figure 16 is above the large stained area on the North elevation; however, the damaged gutter joints are not the sole cause of the staining. The box gutter has been installed over a 1 inch sacrificial blocking. A flat piece of flashing was installed over the blocking and down the back of the gutter apron, Detail 1. It appears the Mansard sill flashing joints (Figure 17) are allowing moisture to migrate behind the sacrificial blocking (area shown by yellow arrow in Detail 1).

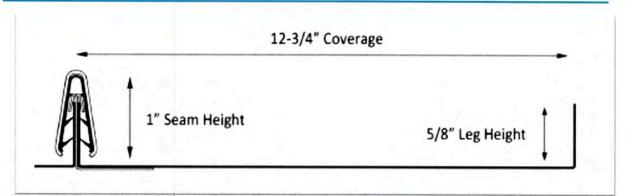
Figure 1: Tee-Panel profile (not to scale).

The material installation matched the original construction documents at this location. The Tee-Panel standing seam metal roofing system has a snap-on seam cap with a vinyl weather seal, Figure 1. This snap-on seam cap is located under the Mansard panels. Exterior Sheet Metal (ESM) disassembled one Mansard panel at the EPDM roof line, Figure 2. ESM was unable to remove the snap-on cap without damaging the vinyl weather seal, Figure 3. If the Tee-Panel system needs to be removed to install the new flat roofing system, the snap-on caps and vinyl weather seals will need replaced.

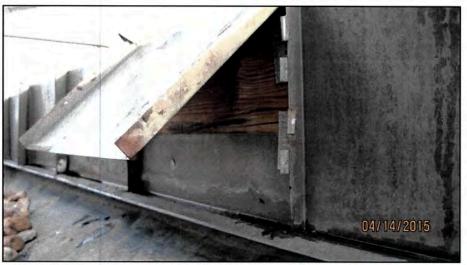
Figure 2: One Mansard panel was removed to review the sill flashing installation and the EPDM membrane termination.

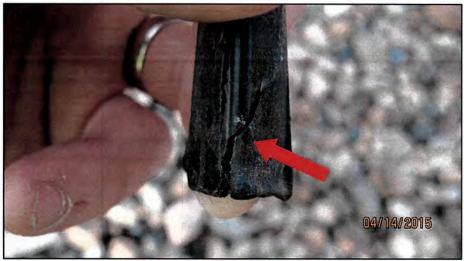
Figure 3: The vinyl weather seal was very brittle and split during the removal of the seam cap (area shown with red arrow).

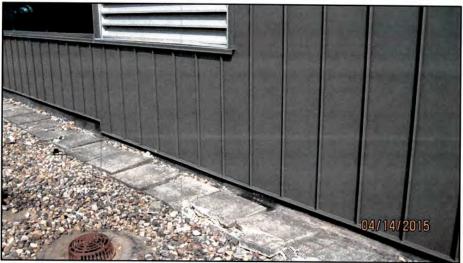
Figure 4: East Elevation, these vertical Tee-Panels will need to be field cut to allow for the installation of the new roofing system.

A best practice roofing termination bar installation height requires an 8 inch minimum height from the finished roof deck elevation. To achieve an 8 inch termination bar height, both the Mansard and the vertical wall panels (Figure 4) will need to be field cut. The new roof will terminate directly below the shorten panels. The finished length of both panel systems will be determined by the type of flashings required by the selected roofing manufacturer. SystemWorks recommends reviewing this detail with the selected roofing manufacturer prior to cutting the panels. **Note:** the Tee-Panel's exposed edge may corrode; the corrosion may cause staining at both locations.

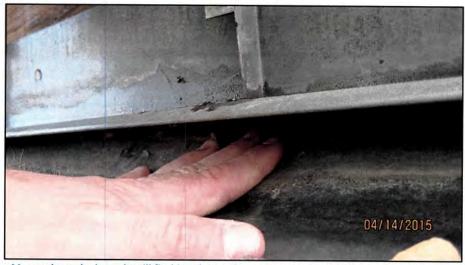
Figure 5: The Mansard panels sit on the sill flashing shown above my hand; the EPDM membrane terminates behind the treaded lumber.

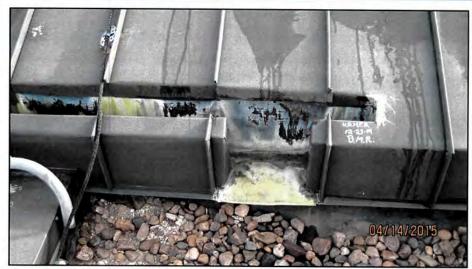
Figure 6: The internal gutter system that is located at the main entrance of the LEC.

The internal gutter system was reviewed with David Harrison and ESM, Figure 6. With the addition of the box-gutter, the internal gutter may be removed. If the internal gutter stays, the new roofing membrane will need to be installed under this system. A new Lead Coated Copper system could be fabricated and installed after the new membrane is installed. To avoid removing the Tee-Panels, the aprons on the existing system would need to be field cut and soldiered over the top of the new Lead Coated Copper system.

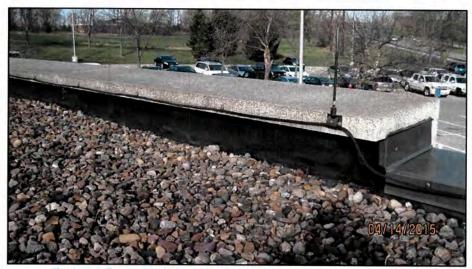
Figure 7: Sally Port Roof, the concrete coping caps are starting to deteriorate.

The stone coping caps are starting to deteriorate, Figure 7. To avoid damage to the new roofing system, SystemWorks recommends removing or replacing the stone caps.

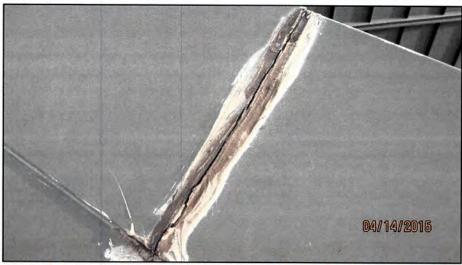
Figure 8: Two-piece ridge cap flashing, the exterior control joint sealant is completely separated.

A large two piece flashing system is installed at the ridge of the Tee-Panel system, Figure 8. This ridge flashing is part of the vertical Tee-Panel termination as well. The majority of the field joints are open and not permanently sealed, Figure 9. There are two field joints ever 10 feet. These open joints are likely allowing moisture to migrate under the Tee-Panel system. If the building is operating under a negative pressure, moisture could be pulled into the condition spaces.

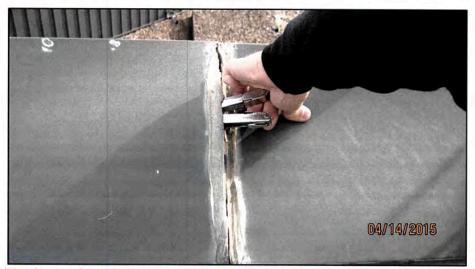
Figure 9: Additional image of the two-piece ridge cap flashing. The majority of the field joints are not permanently sealed.

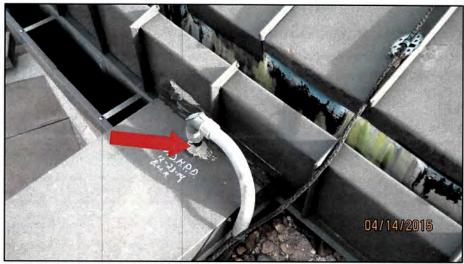
Figure 10: The existing lightning protection system is installed through the center of the coping cap. The sealant at the base of the penetration is starting to fail (area shown with red arrow).

The existing lightning protection system is significantly deteriorated, Figure 10, Figure 11, and Figure 12. Areas where the lightning protection system enters the building are not permanently sealed, Figure 10 and Figure 12. David Harrison will review a replacement system that would reduce penetrations. If the existing system remains, SystemWorks recommends moving all penetrations into the flat roof system. These penetrations can likely be incorporated into the roof's 20 year warranty. The sealant joint shown in Figure 10 is likely to fail in 5 to 7 years.

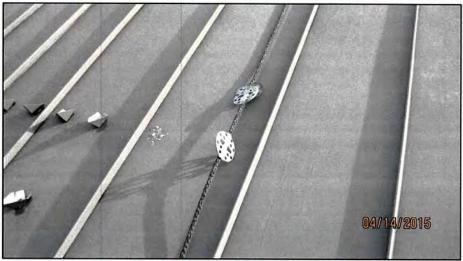
Figure 11: The adhesive base plates are not adhered to the Tee-Panels.

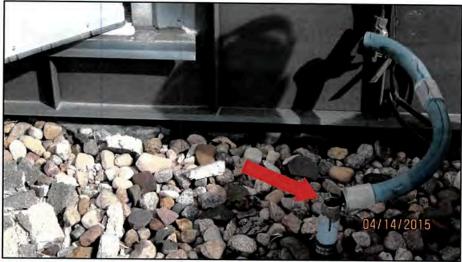
Figure 12: The lightning protection system conduit is not permanently sealed (area shown with red arrow).

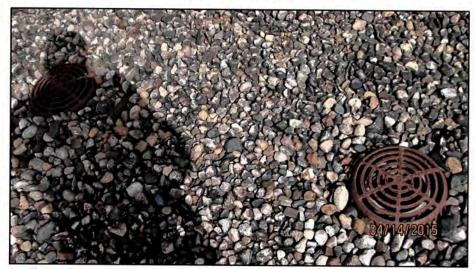
Figure 13: Recommend that all roof drain seals, including over flow drains, be replaced.

The removal of the existing EPDM system will cause uncontrolled movement around the roof drains, Figure 13. To avoid delayed issues, SystemWorks recommends replacing all the primary and overflow roof drains prior to installing the new roof. There also appears to be existing roof curbs (Figure 15) and penetrations that are abandoned or no longer in service, Figure 14. The owner will assist in identifying items that can be removed during construction.

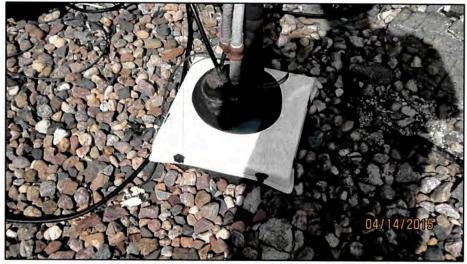
Figure 14: Some of the mechanical curb heights need to be raised.

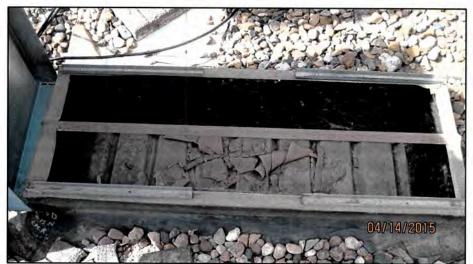
Figure 15: East Elevation, vacant mechanical curb. Roof curbs and penetrations should be capped below the new system to reduce roof penetrations.

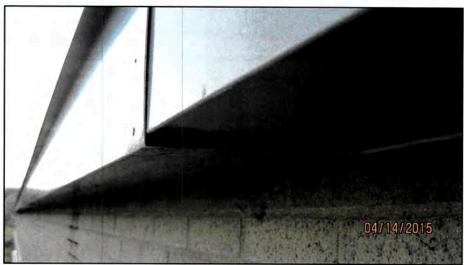
Figure 16: North Elevation, it appears ice buildup has damaged this joint.

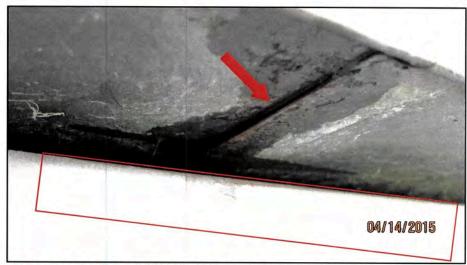
Figure 17: North Elevation, the Mansard sill flashing joints (area shown with red arrow) are allowing moisture to migrate behind the box gutter (area outlined in red).

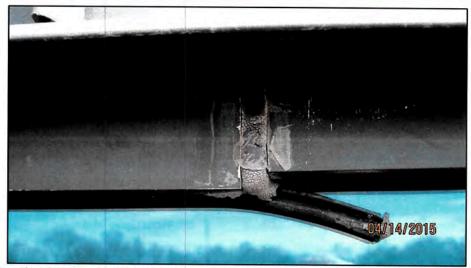
Figure 18: East Elevation, the control joints and gaskets around the exterior windows are separated in multiple locations.

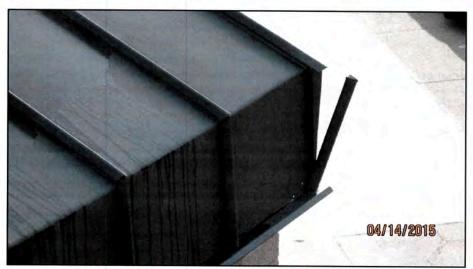
Figure 19: The Tee-Panel seams need repaired in multiply locations.

To achieve the desired 50 year life expectance of the Tee-Panel system and with the constant expansion and contraction that this system will endure due to seasonal changes, an annual maintenance program for the entire system would greatly reduce unnecessary wear and tear. The snap-on caps are not securely fastened in multiply locations, Figure 19.
